Site Inspection Report

Moran Court, Beaconsfield 6162

Lot:	Moran Court, Beaconsfield 6162	Job No.:	12365
Client Name:	Jenny Way	Date:	2 Aug 2017

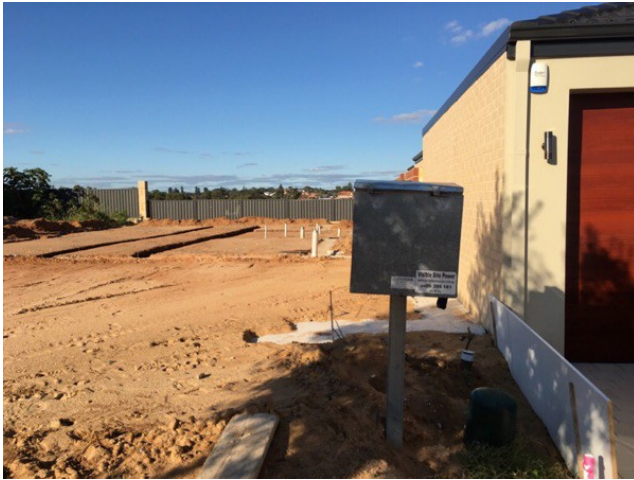
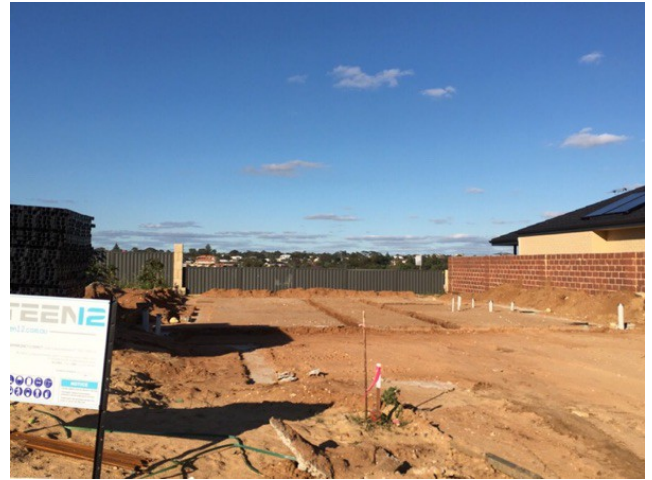
Safety Issues - Overhead power cables
Taken : 03/08/2017

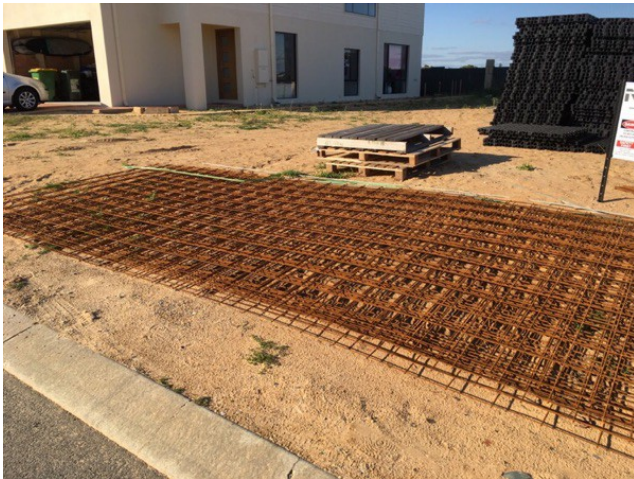
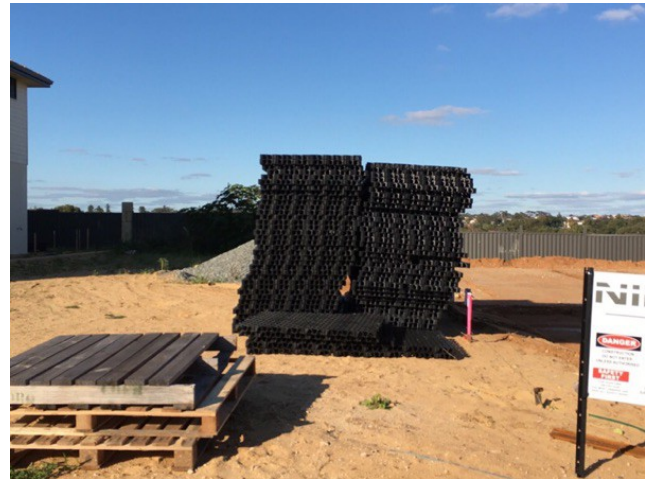
Safety Issues - Possible public liability
Taken : 03/08/2017

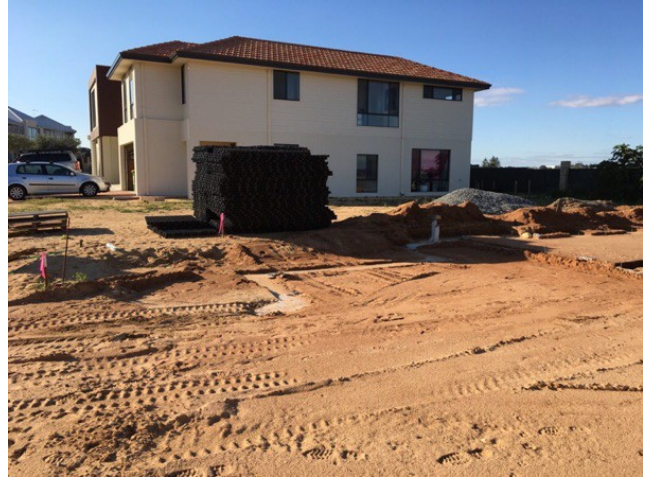
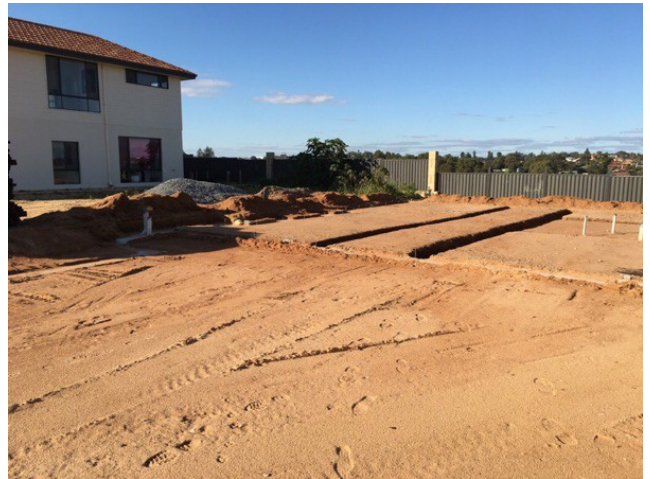
Fences/Retaining - Existing fence to left
Taken : 03/08/2017
