Routine Inspection Report

Address	19 Van Kleeft Circuit, Mount Claremont 6010
Owner Name	Mark John
Tenant Name	Mr Mary Lewis
Lease Start / Expiry	29 Aug 2023 / 29 Aug 2024
Lease Details	12 Months
Rented for	\$ 1,500.00 per week
Inspection Date	28 Aug 2023

19 Van Kleef Circuit, Mount Claremont 6010

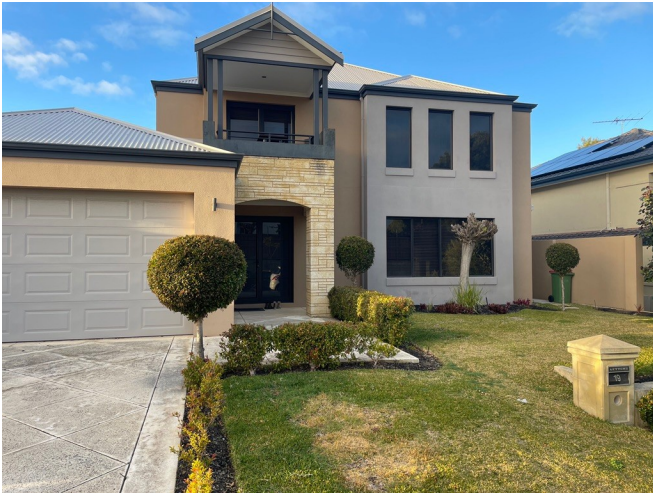
Front Gardens :

Area of Property	Clean	Undamaged	Working	Maintenance Required	Notes
Front Gardens	✓	✓	✓		Garden neat and tidy. Lawn could do with weed spray and fertiliser.
Driveway	✗	✓	✓		Some oil stains which could be jet cleaned
Paving	✓	✓	✓		Clear of weeds
Garden	✓	✓	✓		Black mulch laid which looks good
Grass	✓	✓	✓		Mowed and edged
Verandah	✓	✓	✓		Gutter replaced last winter no further leaking reported
Letterbox/Street Number	✓	✓	✓		Numbering, clear and letterbox all good
Gutters/Downpipes	✓	✓	✓		Clear of leaves, no problems to report
Watering System	✓	✓	✓	✓	Retic needs to be serviced this summer
Entry/Exterior	✓	✗	✓	✓	Render chipped on front pillar
Door	✓	✓	✓		Frosting film installed on front door
Screen Door/Security Door	✓	✓	✓		Secure and working
Entry Lighting	✓	✓	✓		Single downlights at entrance, tested and working
Bricks	✓	✓	✓		Issues with render on front pillar. Refer photo.
Garage	✓	✓	✓		Roller door working and three remotes tested

At this stage we suggest repairs to the render on the front pillar is carried out within three months.
Recommend installing an extractor fan in the laundry for ventilation.
Lawns require fertiliser, and retic needs servicing before summer.

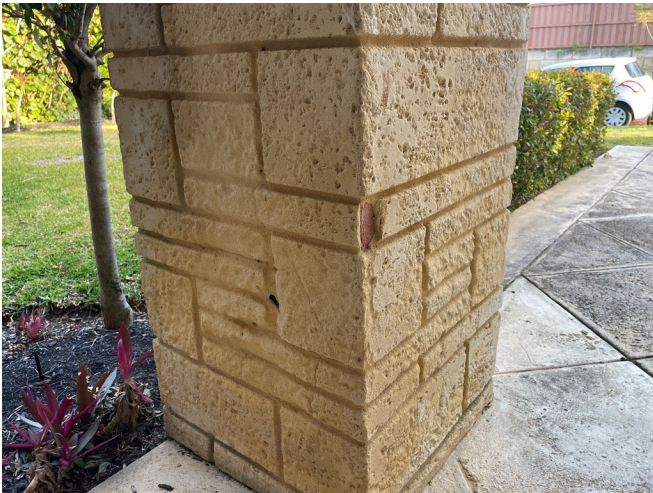
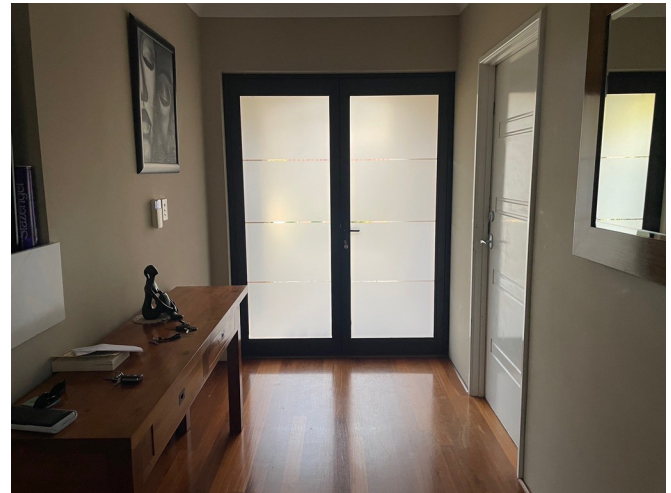
Entry/Exterior :

1. Render on front pillar needs fixing.
2. Pantry sensor light, not working.
3. Pantry door is scraping on kitchen floor and needs adjusting.

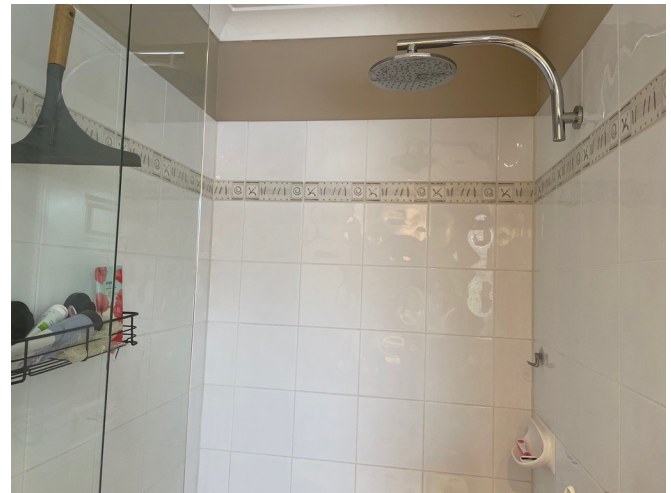
Bathroom 1 :

Lighting	✓	✓	✓		All lights working
Ceiling Fan/Air Conditioner	✓	✓	✗	✓	Requires servicing, strange sound coming from vent
Bathroom 1	✓	✓	✓		
Door	✓	✓	✓		
Floor	✓	✓	✓		All tiles wipes clean, area neatly presented
Sink/Taps	✓	✓	✗	✓	Tap(s) are leaking
Shower/Bath/Taps	✓	✓	✓		Wet areas are clean and tidy
Towel Rails	✓	✓	✗		Requires a new rail
Heating/Exhaust Fan/Vent	✓	✓	✗	✓	Heat globe not working
Bathroom 2	✓	✓	✓		
Bedroom 1	✓	✓	✓		Neat and tidy
Door	✓	✓	✓		Painted white
Floor	✓	✓	✓		Carpet clean, no stains
Lighting	✓	✓	✓		Tested and working
Windows/Window Safety Devices	✗	✓	✓		Windows need cleaning
Bedroom 2	✓	✓	✓		No problems to report
Bedroom 3	✓	✓	✓		A lovely inspection, no problems to report
Kitchen/Meals	✓	✗	✗		Pantry sensor light, not working and pantry door, scraping on floor
Bench	✓	✓	✓		No noted marks
Oven	✓	✓	✓		Well cleaned
RHood	✓	✓	✓		Free from grease
Pantry	✓	✗	✗	✓	Pant light sensor is not working and the pantry door is scraping on the wooden floor. It requires adjusting

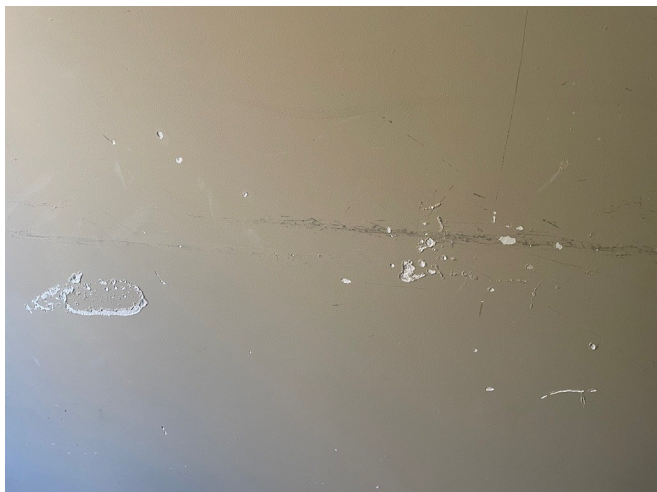
[Laundry:](#)

Door	✓	✓	✓		Double doors painted white
Floor	✓	✓	✓		Carpet has no stains
Walls	✓	✓	✓		No marks
Ceiling	✓	✓	✓		Painted white
Lighting	✓	✓	✓		Dimmers installed
Dining	✓	✓	✓		A lovely inspection, no problems to report
Toilet	✓	✓	✓		No problems to report
Laundry	✓	✗	✓		The paint is peeling along the walls, this indicates damp from dryer, as it is not ventilated.
Walls	✓	✓	✓		Paint peeling and requires repainting
Trough	✓	✗	✓		Showing signs of rust
Rear Gardens	✓	✗	✓	✓	Neat and tidy
Paving	✓	✓	✓		Clear of weeds
Grass	✓	✓	✓		Some holes where the dog has dug , but otherwise very neat the grass has been mowed and edged.
Security/Safety	✓	✓	✓		Security doors or working House alarm tested and working
Smoke Alarms	✓	✓	✓		Tested and working
RCD/Safety Switch	✓	✓	✓		Compliant with regulations
