# Leak Detection Report

Site Address	1 Leaky Street, Subiaco 6008
Job Number	#40888
Customer Name	Lucy Power
Assessment Required	CCTV inspection of sewer and stormwater drainage.
Assessment Date	Tuesday, 1 September 2020

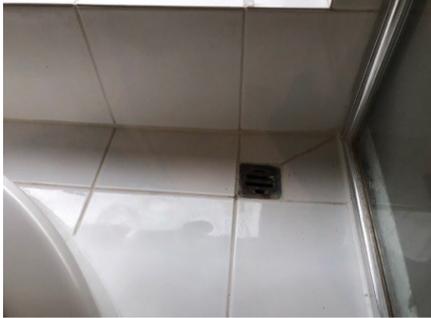
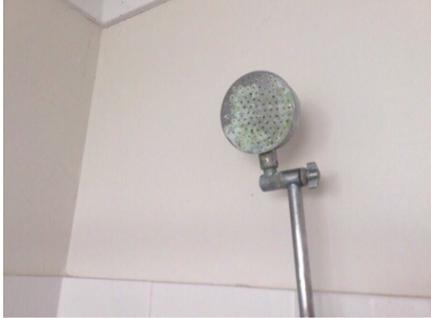
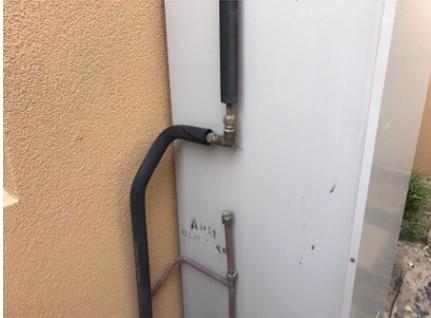
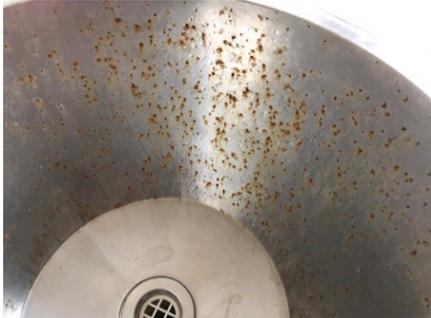
<b>Client Assessment</b>	<p>The client reported water present on external of ensuite bathroom at rear of property. The client has concerns this seems worse when rain is present. Previous repairs have been carried out on roof with previous claim.</p>
<b>Inspection Summary</b>	<p>As per work order CCTV inspection carried out on sewer and stormwater drainage systems. No issues present in either line with both been clear including CCTV inspection of bathroom sua drainage with no blockage present. We have entered roof space above affected area with no water or moisture present in roof space. We have also assessed roof above affected area with no water ingress points visible. External slab level is significantly low than internal slab indicating no issue with drainage or surface water affecting internal of property. Previous report completed showing a leak from bath/shower mixer causing Issue. Please refer to previous report.</p>

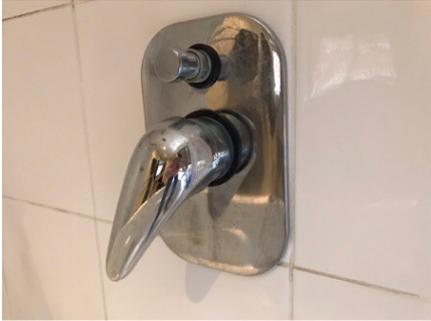
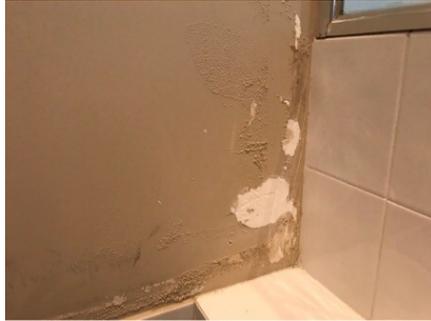
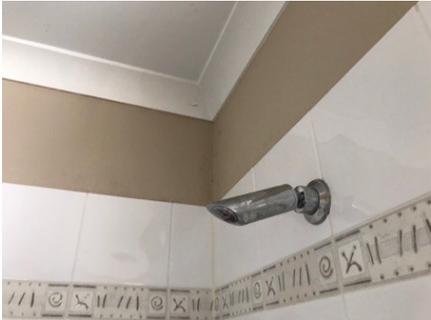
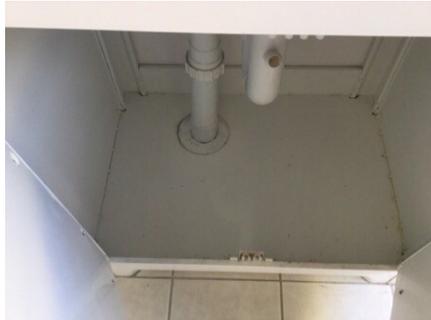
<b>Kitchen</b>	<b>No</b>	
<b>Main Bathroom</b>	<b>Yes</b>	Shower mixer needs replacing
<b>Other Bathroom</b>	<b>No</b>	
<b>Ensuite</b>	<b>Yes</b>	Some mould on ceiling, check for damp in walls.
<b>Laundry</b>	<b>Yes</b>	Washing machine hose needs replacing as it's disintergrating
