## Virtual Routine Inspection Report

Address	200 Hampden Road, Nedlands 6009
Owner Name	Grace Green
Tenant Name	Mark Lester
Lease Start / Expiry	7 Apr 2020 / 7 Apr 2021
Lease Details	12 Months
Current rented for	\$ 1,200.00 per month
Inspection Date	7 Apr 2020

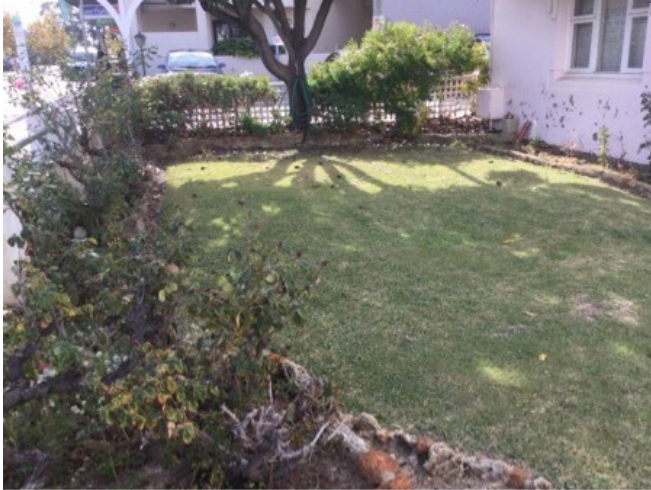
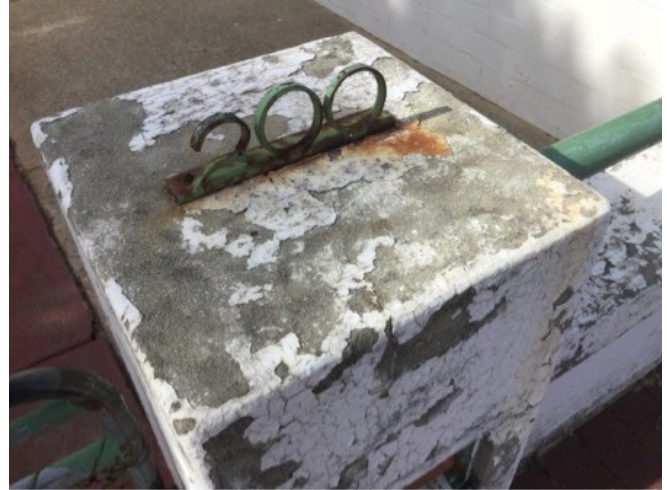
Front Gardens  
Taken : 07/04/2020

We have made a couple of requests to the weeds in the front garden as detailed in the report but nothing of concern.

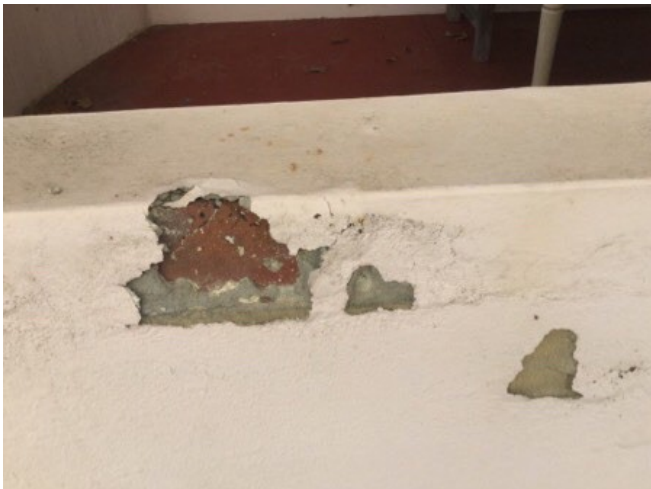
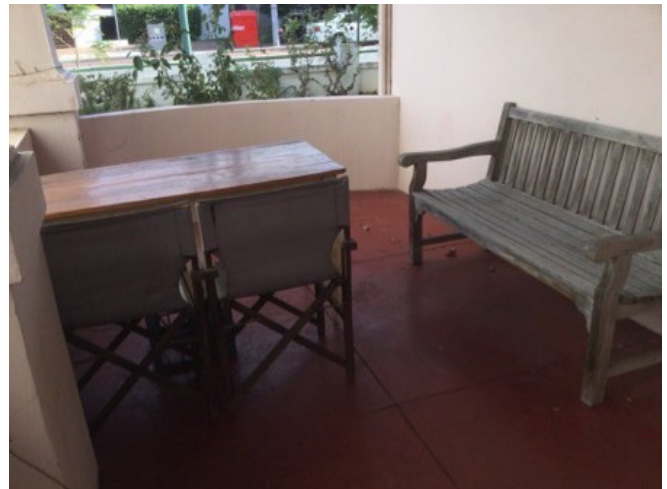
Entry/Exterior  
Taken : 16/04/2020

1. Render on front veranda required
2. Paint front fence/letterbox
3. Replace heat globe in bathroom
4. Sensor in pantry not working

At this stage we suggest the repairs to the exterior veranda are carried out within 3 months. Overall the property is in good condition for its age.

We do recommend the maintenance items as highlight should be carried out with the render on the veranda the most urgent.
