Site Inspection Report

Moran Court, Beaconsfield 6162

Lot:	Moran Court, Beaconsfield 6162	Job No.:	12365
Client Name:	Jenny Way	Date:	2 Aug 2017

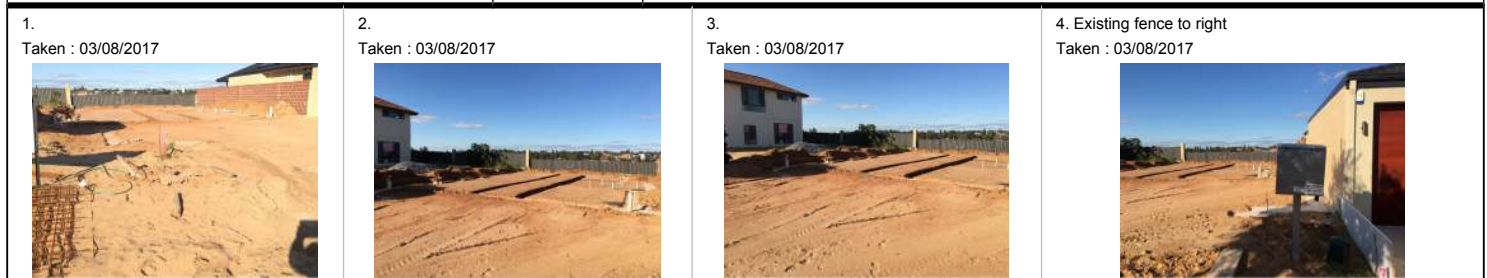
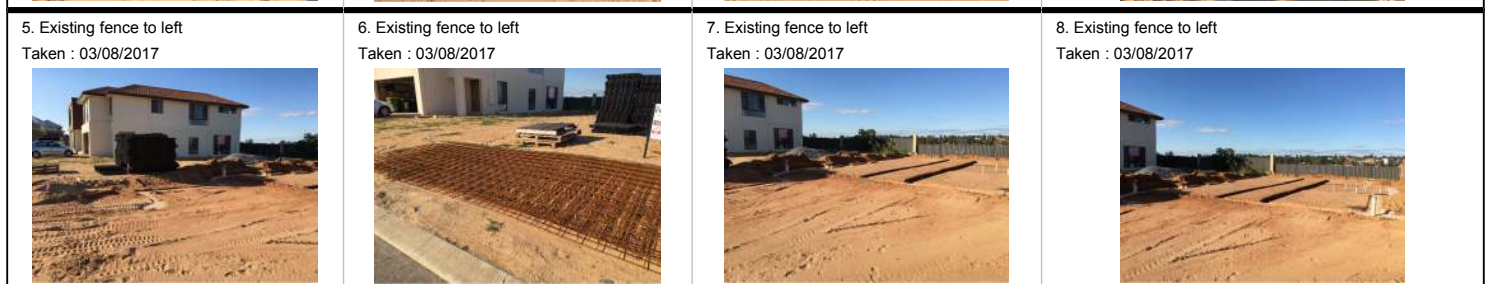
<p>9. Existing fence to rear Taken : 03/08/2017</p>  	<p>10. Existing fence to rear Taken : 03/08/2017</p>  		
--	--	--	--

Area	Yes/No	Comments
2 - Fences/Retaining	Yes	Recommend site is secured as adjoining block is POS.
Existing fence to front	No	
Existing fence to left	No	Recommend this boundary is secured
Existing fence to right	Yes	
Existing fence to rear	Yes	
Existing retaining walls	No	Not required
Additional retaining required	Yes	Possibly at rear of property. Recommend Inspection.
Chemical injection required	No	Not at this stage
Undermining concerns	No	
Dilapidation Report required	Yes
