Routine Inspection Report

Address	19 Van Kleeft Circuit, Mount Claremont 6010
Owner Name	Mark John
Tenant Name	Mr Mary Lewis
Lease Start / Expiry	29 Aug 2023 / 29 Aug 2024
Lease Details	12 Months
Rented for	\$ 1,500.00 per week
Inspection Date	28 Aug 2023

19 Van Kleef Circuit, Mount Claremont 6010

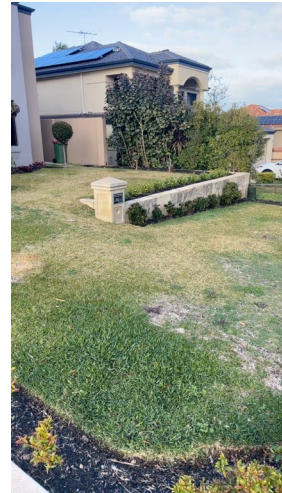
Front Gardens :

Area of Property	Clean	Undamaged	Working	Maintenance Required	Notes
Front Gardens	✓	✓	✓		Garden neat and tidy. Lawn could do with weed spray and fertiliser.
Driveway	✗	✓	✓		Some oil stains which could be jet cleaned
Paving	✓	✓	✓		Clear of weeds
Garden	✓	✓	✓		Black mulch laid which looks good
Grass	✓	✓	✓		Mowed and edged
Verandah	✓	✓	✓		Gutter replaced last winter no further leaking reported
Letterbox/Street Number	✓	✓	✓		Numbering, clear and letterbox all good
Gutters/Downpipes	✓	✓	✓		Clear of leaves, no problems to report
Watering System	✓	✓	✓	✓	Retic needs to be serviced this summer
Entry/Exterior	✓	✗	✓	✓	Render chipped on front pillar
Door	✓	✓	✓		Frosting film installed on front door
Screen Door/Security Door	✓	✓	✓		Secure and working
Entry Lighting	✓	✓	✓		Single downlights at entrance, tested and working
Bricks	✓	✓	✓		Issues with render on front pillar. Refer photo.
Garage	✓	✓	✓		Roller door working and three remotes tested

At this stage we suggest repairs to the render on the front pillar is carried out within three months.
Recommend installing an extractor fan in the laundry for ventilation.
Lawns require fertiliser, and retic needs servicing before summer.
