## Virtual Routine Inspection Report

Address	200 Hampden Road, Nedlands 6009
Owner Name	Grace Green
Tenant Name	Mark Lester
Lease Start / Expiry	7 Apr 2020 / 7 Apr 2021
Lease Details	12 Months
Current rented for	\$ 1,200.00 per month
Inspection Date	7 Apr 2020

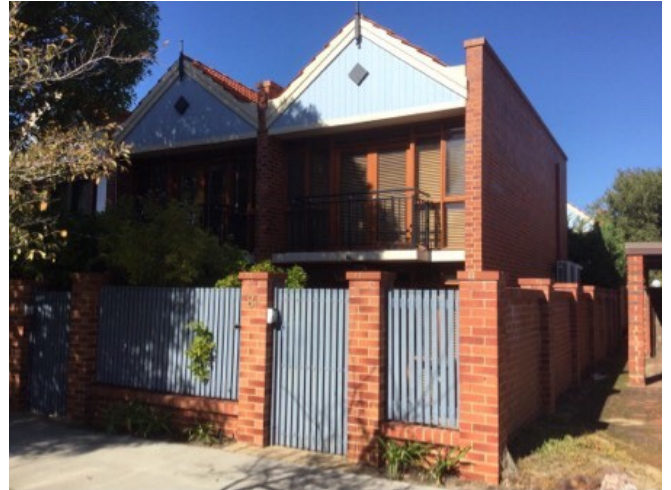
Our Summary  
Taken : 16/04/2020

Overall we are very happy with the way the tenant is maintaining the property and especially the lounge reprint as discussed.

We have made a couple of requests to the weeds in the front garden as detailed in the report but nothing of concern.

We do recommend the maintenance items as highlight should be carried out with the render on the veranda the most urgent.
